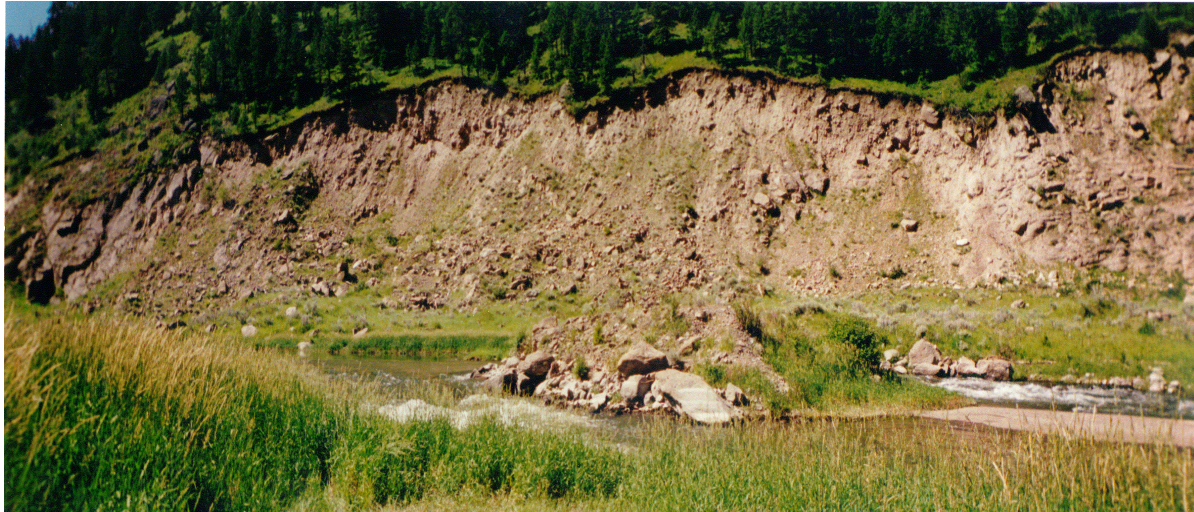
*Photograph A- 11. In many cases, landslides occurred at the same location as previous slides, thus enlarging existing riffles or islands visible in 1972 aerial photographs prior to the construction of Teton Dam, such as this island at the mouth of Spring Hollow. USBR photograph by Tim Randle, 1997.*

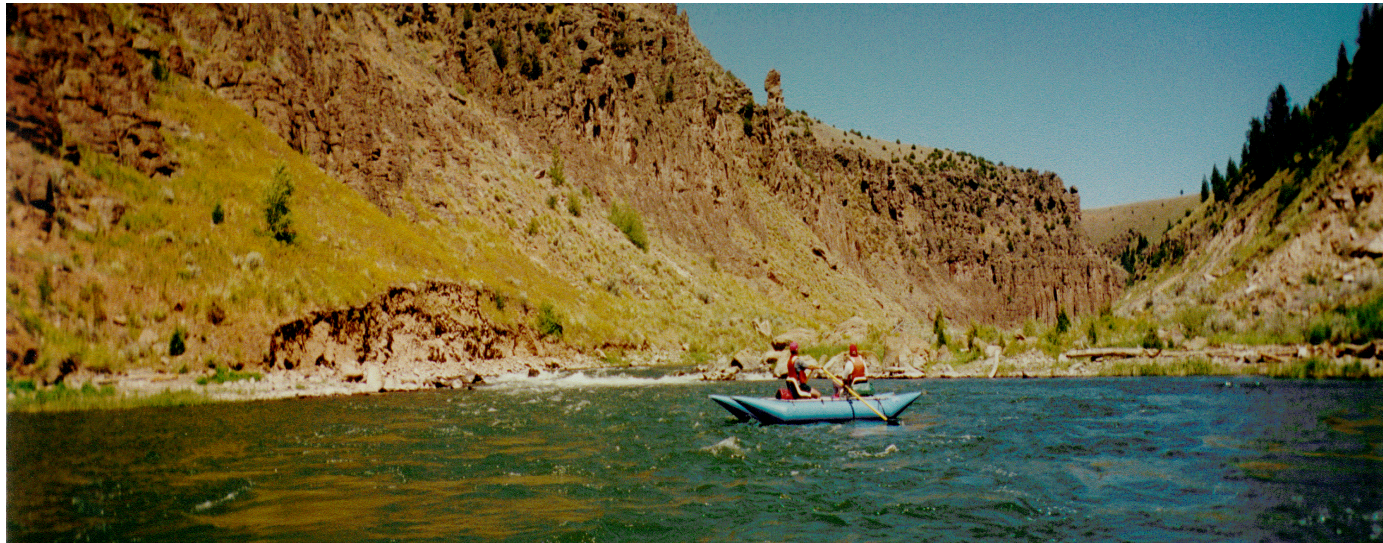
*Photograph A- 12. In this section, where the canyon is wider and the river has more room to meander, landslide debris has deflected the river channel, causing erosion of the previously stable bank. USBR photograph by Tim Randle, 1997.*

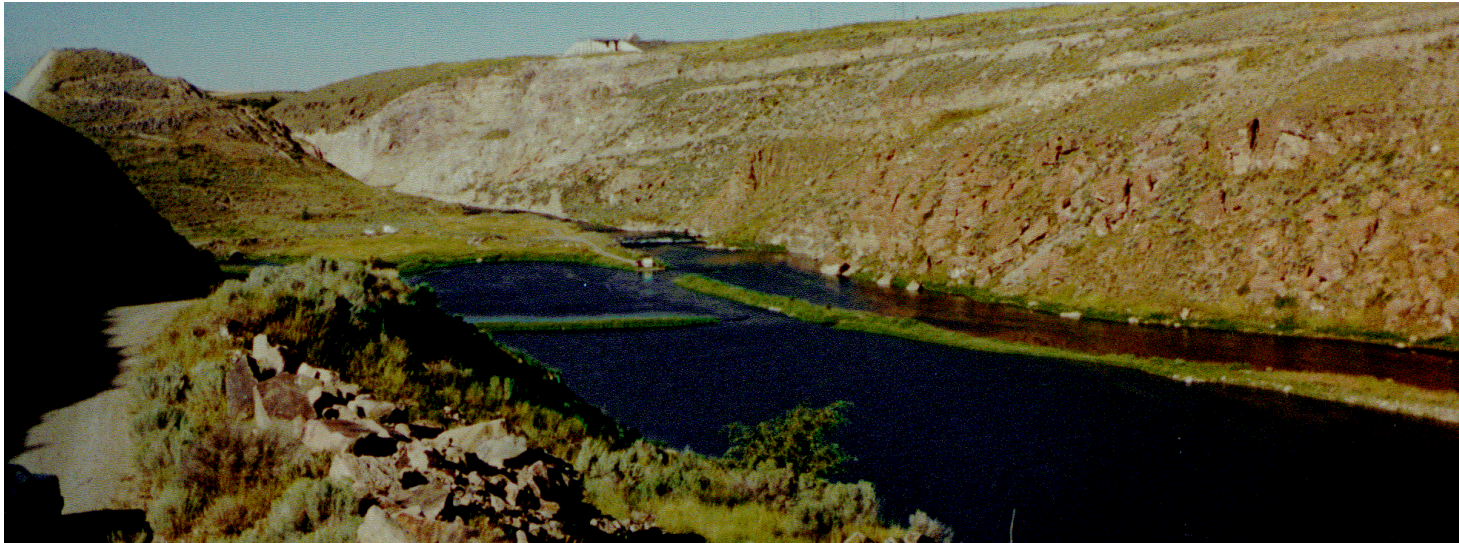
*Photograph A- 15. The first survey reach (measured in 1997) was the borrow ponds, which extend for 1½ miles upstream of Teton Dam. The borrow ponds consist of two ponds which were excavated during the construction of Teton Dam. USBR photograph by Tim Randle, 1997.*

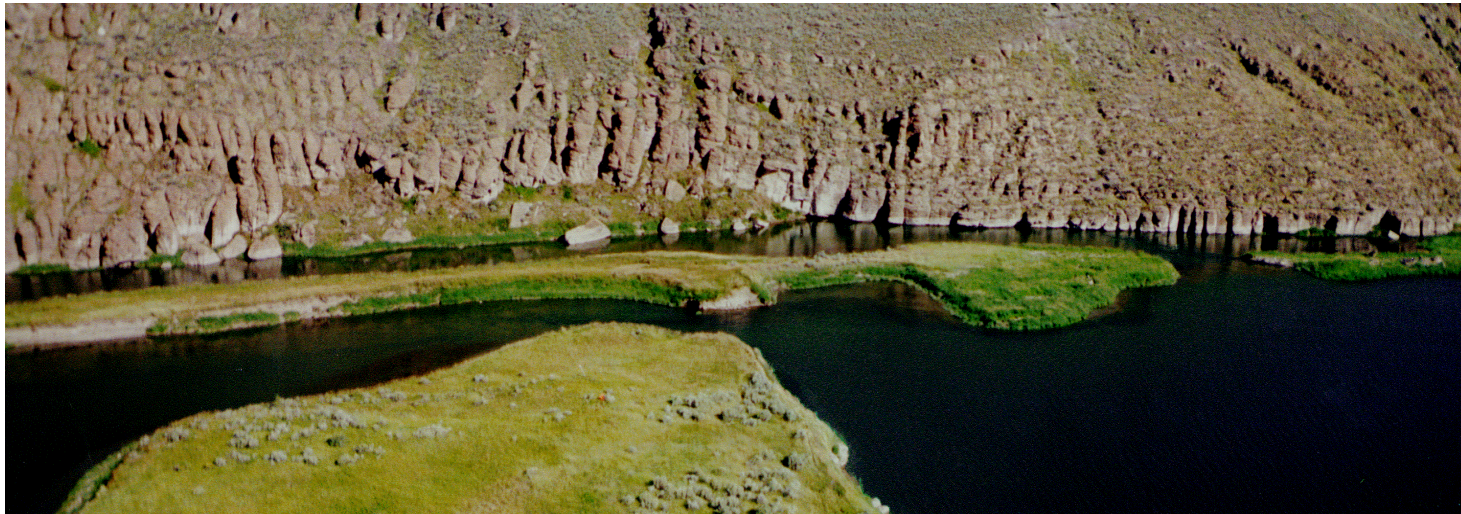
*Photograph A- 16. A river channel along the right canyon wall parallels the borrow ponds and was constructed to bypass flows around the downstream pond. USBR photograph by Tim Randle, 1997.*
